**CULTURAL LANDSCAPE REPORT  
NORTH BRIDGE UNIT  
MINUTE MAN NATIONAL HISTORICAL PARK**

**SITE HISTORY, EXISTING CONDITIONS,  
ANALYSIS & EVALUATION, TREATMENT RECOMMENDATIONS**

**CONCORD  
MASSACHUSETTS**

January 2004

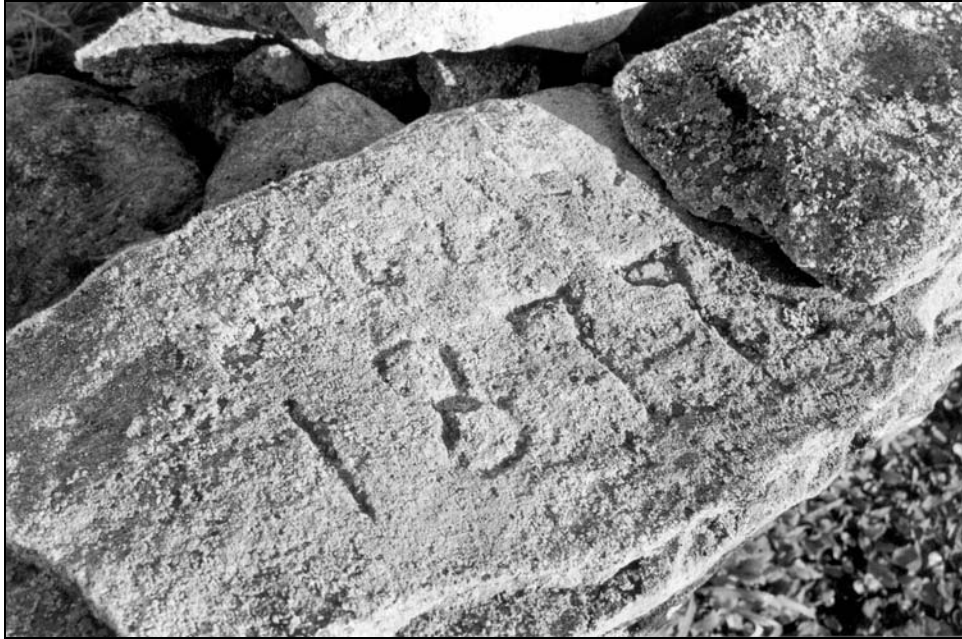
Figure 128. Cap stone at western end of stone wall (W-24), with the engraved date Nov 16, 1879, 2002. (OCLP)

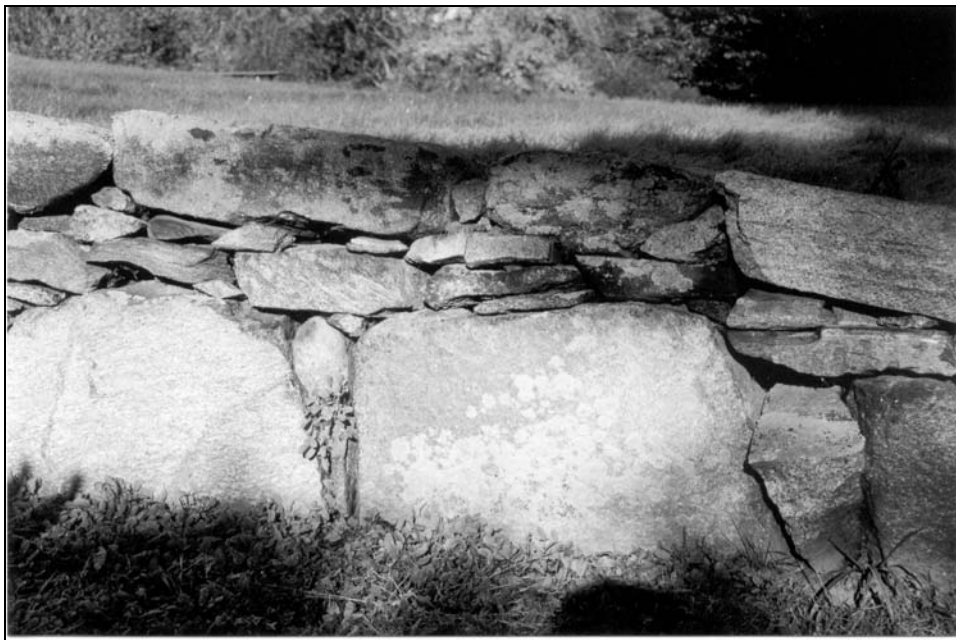
Figure 129. View northwest from Liberty Street of stone wall (W-24), 2002. (OCLP)

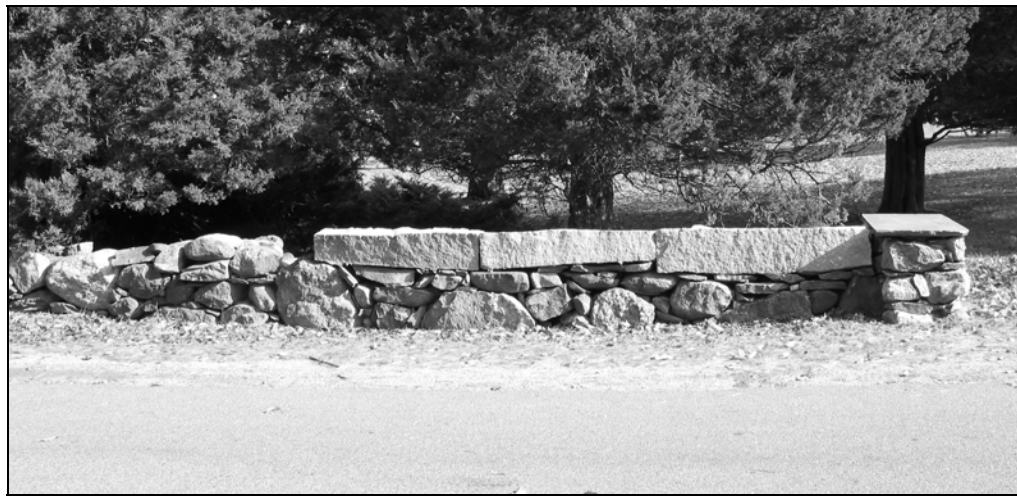
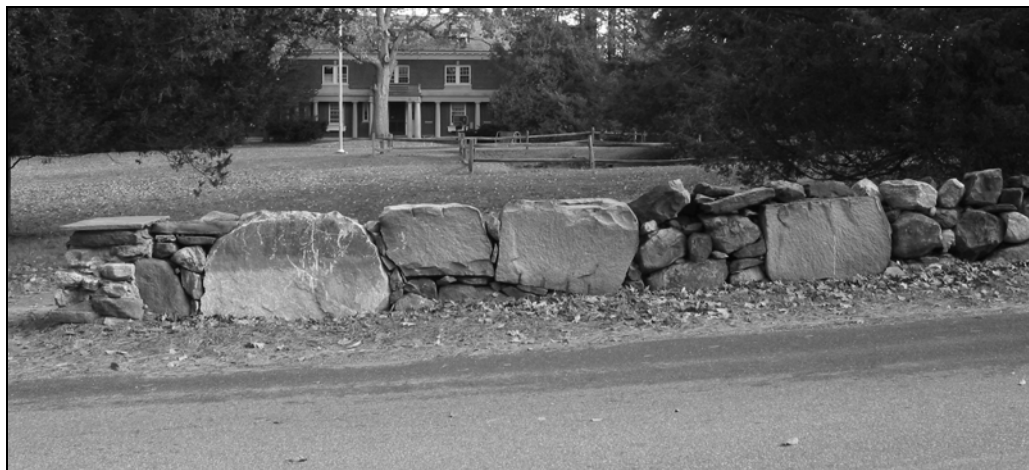
**Figure 130.** View east of stone wall (W-30), section B, 2002. Top photo depicts portion north of the Groton Road trail entrance and the bottom photograph depicts the portion south of the trail entrance. (OCLP)

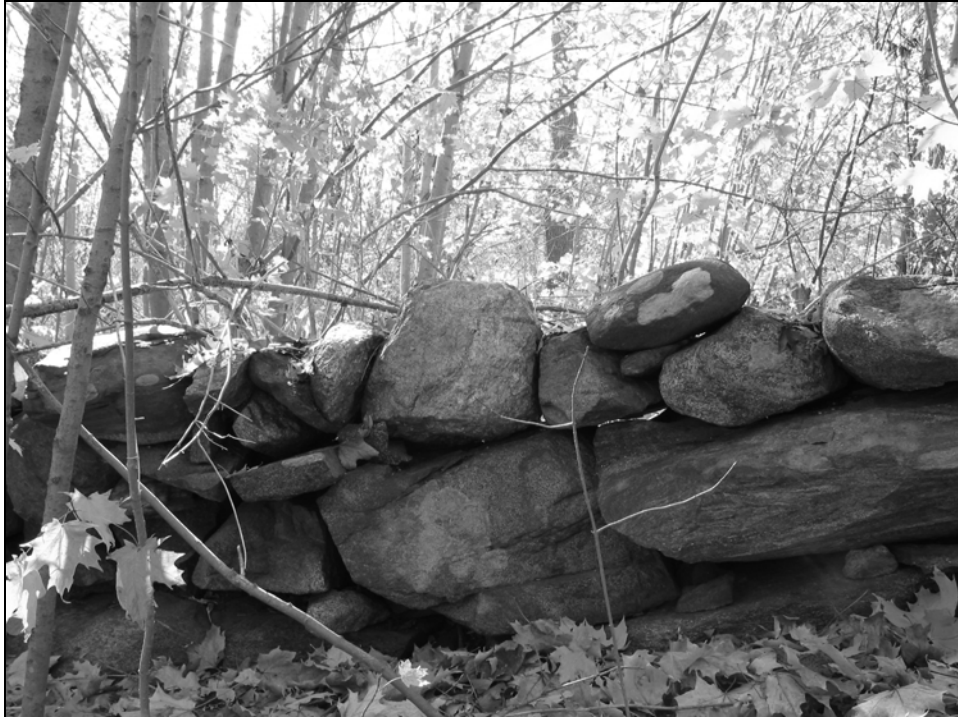
Existing Condition: The thrown stone wall extends from Liberty Street to the Concord River, between Keyes Pasture and the Captain David Brown houselot. It is composed primarily of large and medium-sized stones. The wall stands 24 to 42 inches high and 24 inches wide. It is in fair condition (Figure 131). One opening interrupts the line of the wall, the portion removed by NPS archeologists in the mid-1960s.

Figure 131. View west of stone wall (W-34), 2002. (OCLP)

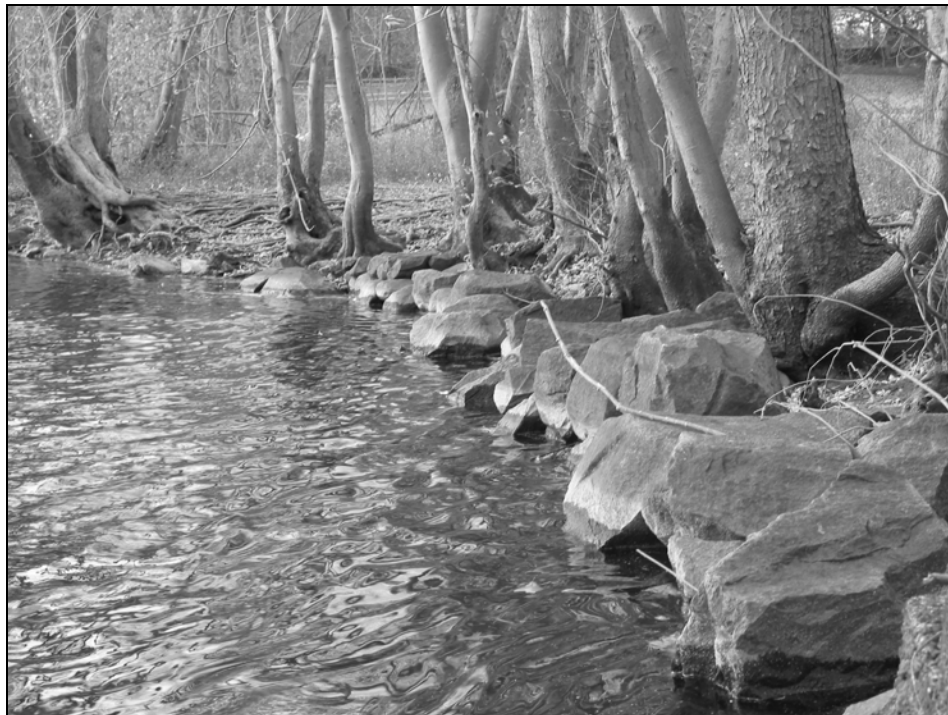
Existing Condition: A low stone wall extends along the southern boundary of the Battle Lawn estate along the Concord River (Figure 132). The wall may extend further along the river in both directions than indicated on Figure 83.

Figure 132. View northwest of stone wall (W-35), 2002. (OCLP)

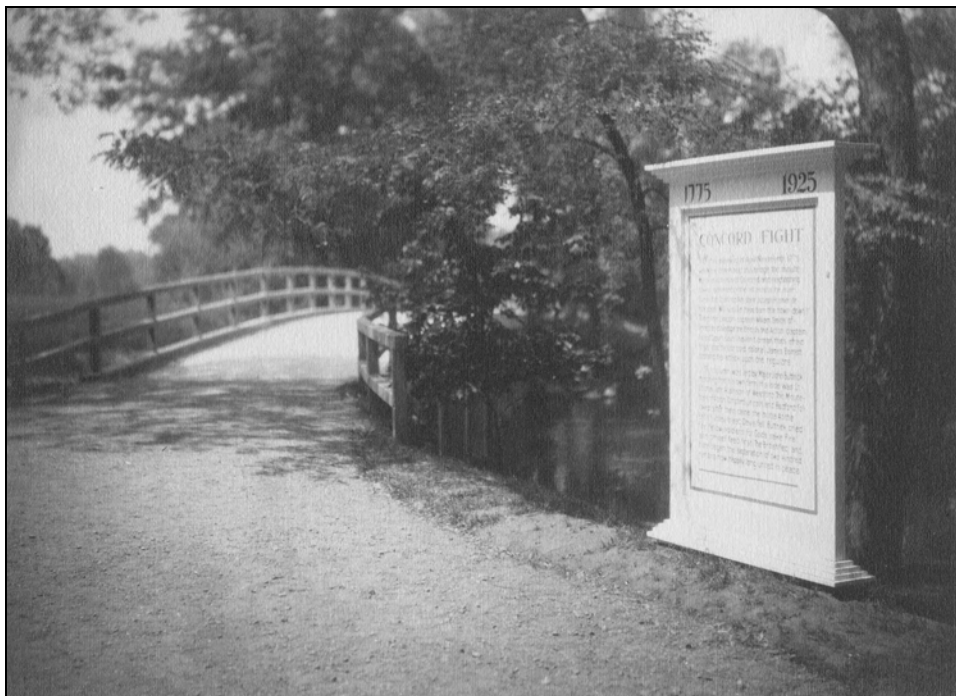
Figure 133. Concord Fight Sign. Photograph by James H. Tolman, c. 1925. (MIMA Photographic Collection, Box 12, #34290, MIMA Archives)

Historic Condition: In 1925, a wooden sign titled "Concord Fight" was erected adjacent to the eastern abutment (north side) of the 1909 commemorative North Bridge. The sign, a predecessor of the extant Concord Fight Marker, included a battle narrative written by local historian Allen French (Figure 133). In 1955, Concord replaced the sign with a cast bronze tablet set in a granite boulder. The French narrative that appears on the original sign was inscribed in raised letters on the bronze tablet.

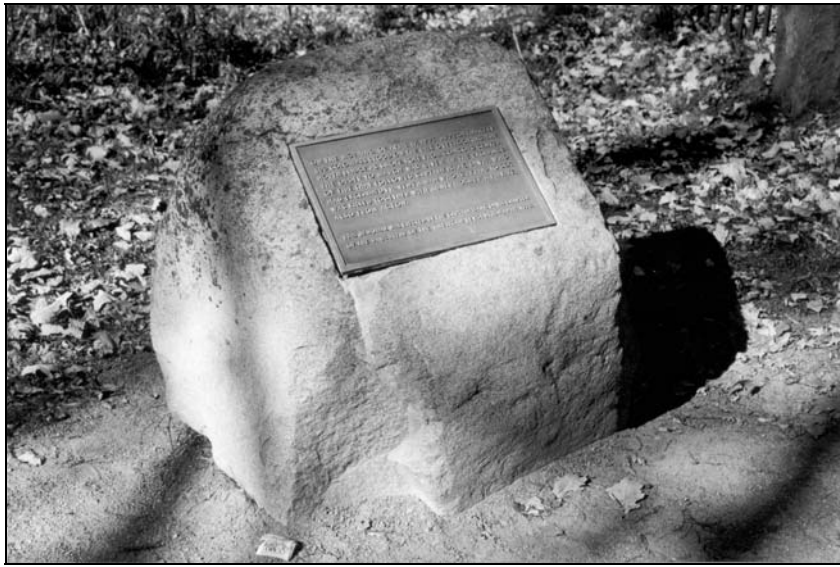
Existing Condition: The DAR Marker is located west of The Minute Man statue, on the north side of the path leading to the North Bridge Visitor Center. The marker consists of a 36-inch uncut granite boulder with an aluminum tablet (Figure 135).

**Figure 135. Daughters of the American Revolution (DAR) Marker, 2002. (OCLP)**

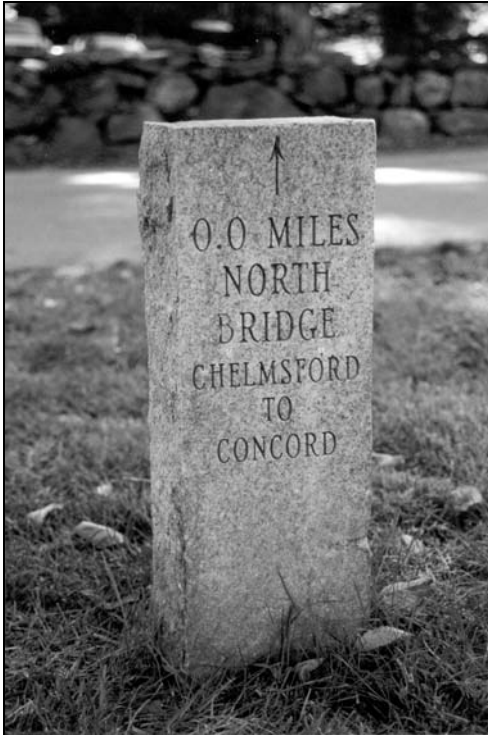
Existing Condition: The Mile Marker stands on a small grass island at the intersection of Liberty Street and Estabrook Road. The cut granite marker measures 24 inches x 6 inches x 8 inches (Figure 136).

Figure 136. Mile Marker, 2002. (OCLP)

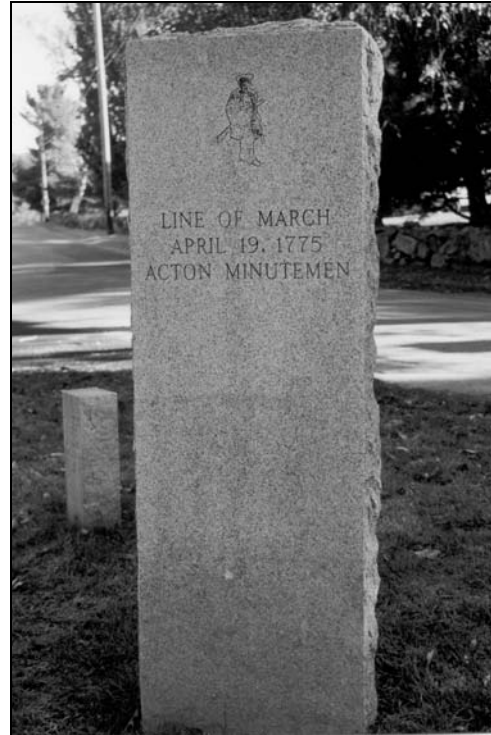
Existing Condition: The Line of March Marker stands on a small grass island at the intersection of Liberty Street and Estabrook Road. The cut granite marker measures 72 inches x 24 inches x 7 inches (Figure 137).

Figure 137. Line of March Marker, 2002. (OCLP)

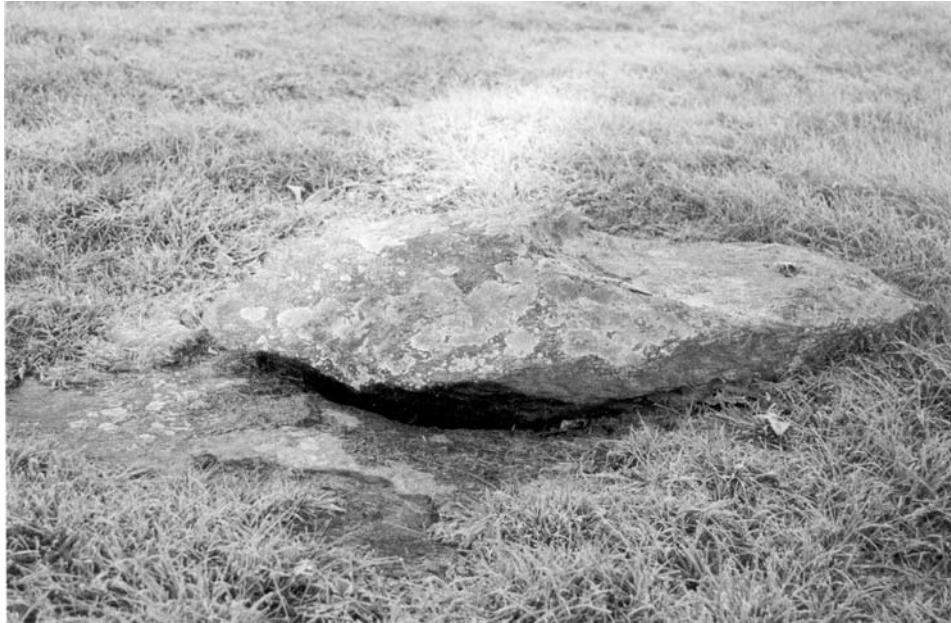
covered by grass and moss. A hole measuring about 18 inches in diameter is cut in the center of the stone. A large, flat rock covers the wellhead (Figure 138). The second wellhead (F-04) is located in front of the Major John Buttrick house garage. A mature barberry growing on top of the wellhead blocks a clear view of the feature; however, it appears to be similar in nature to the other stone wellhead located on the Major John Buttrick house lot.

Figure 138. Stone wellhead (F-03) located on the Major John Buttrick houselot, 2002. (OCLP)

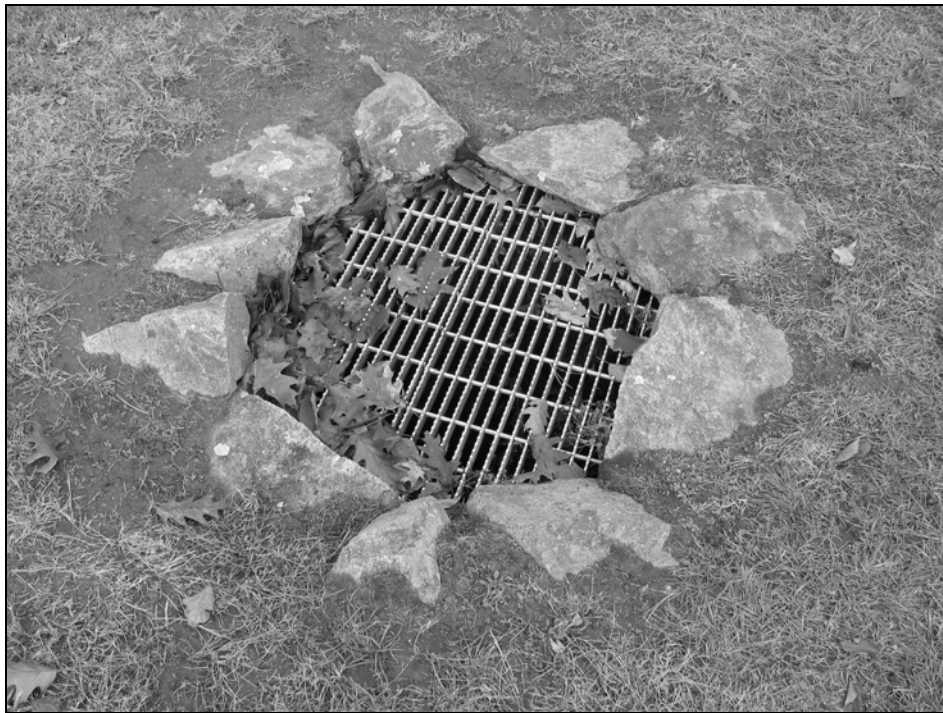
Existing Condition: The circular well heads are lined by large rocks and covered with metal grates (Figure 139).

Figure 139. Stone wellhead located north of the Ephraim and/or Willard Buttrick house site, 2002. (OCLP)

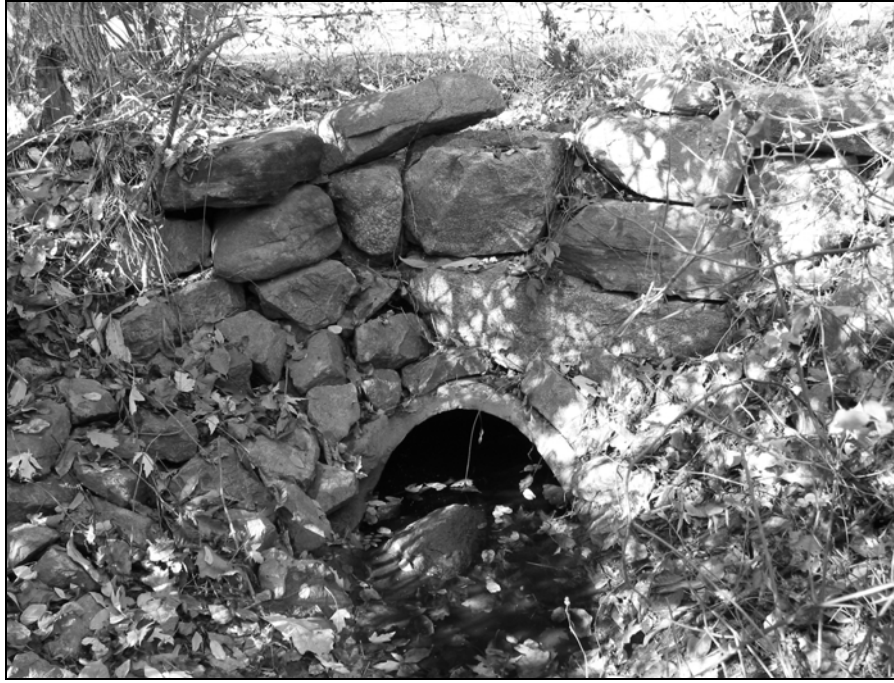
Existing Condition: Two culverts are located on Liberty Street, one at the eastern end (F-07) of the street (mentioned above) and another at the western end (F-08) of the street. Both culverts have fieldstone heads and fieldstone side walls (Figure 140).

Figure 140. Stone culvert (F-08) on Liberty Street, 2002. (OCLP)

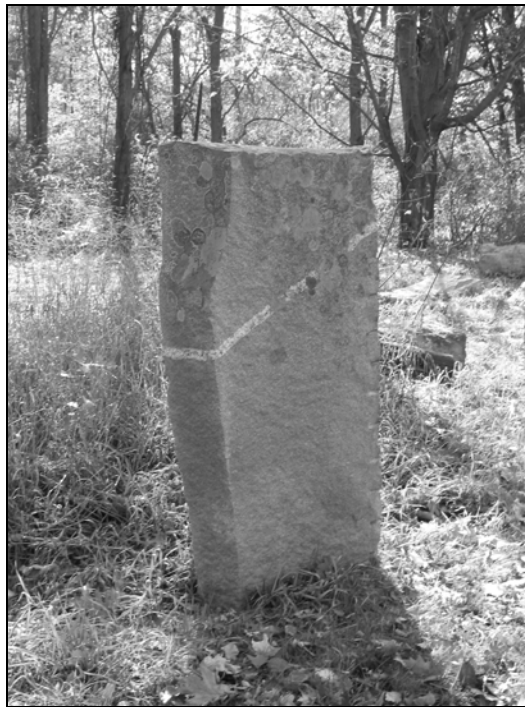
Existing Condition: The approximate 5-foot cut stone marker stands on Liberty Street, just right of the intersection of Liberty Street and the pre-1964 alignment of Lowell Road (Figure 142).

Figure 142. Stone marker on Liberty Street, 2002. (OCLP)

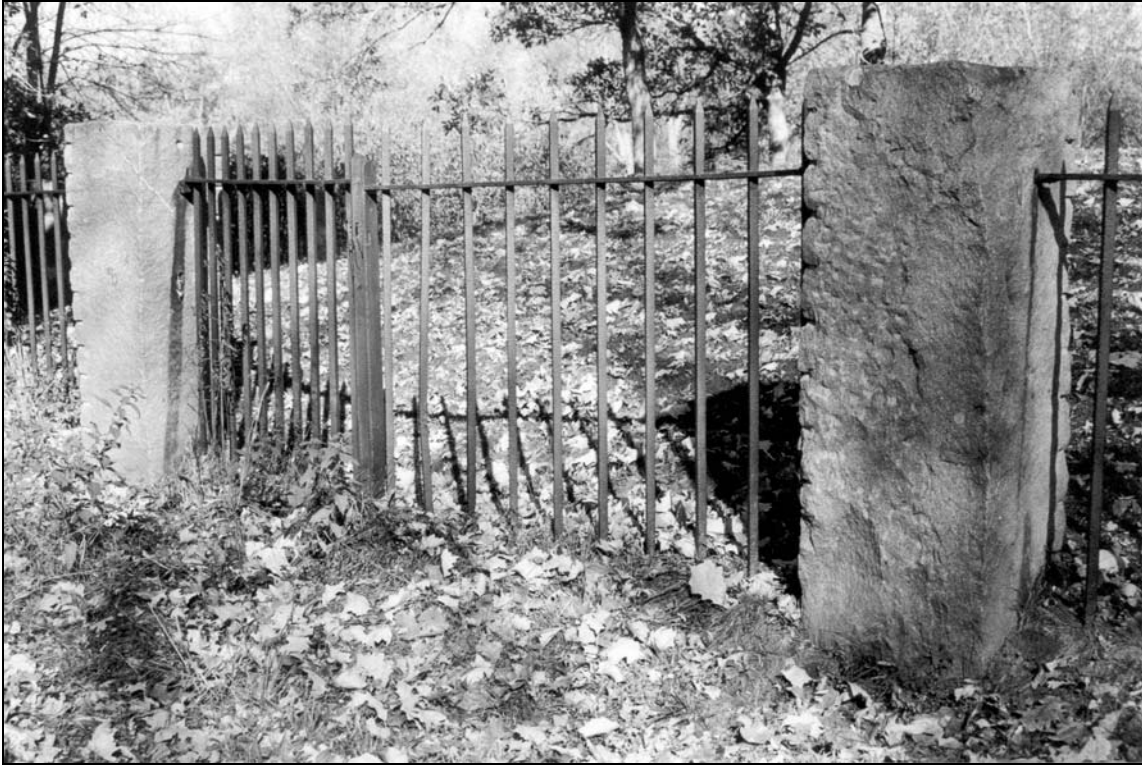
**Figure 143. The Minute Man statue fencing, 2002. Depicted in the photograph is the gate that originally stood at the entrance to the battleground, before 1875. (OCLP)**

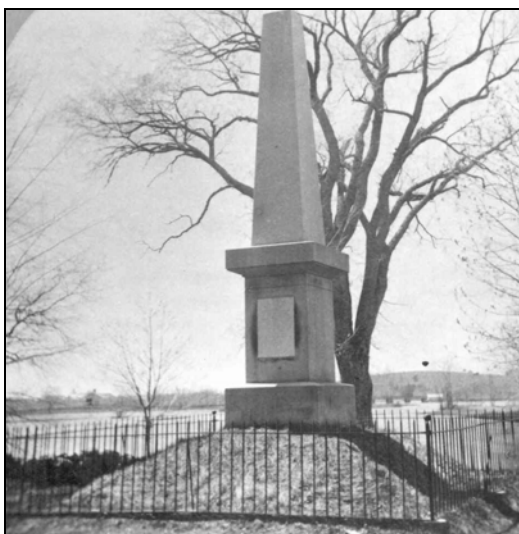
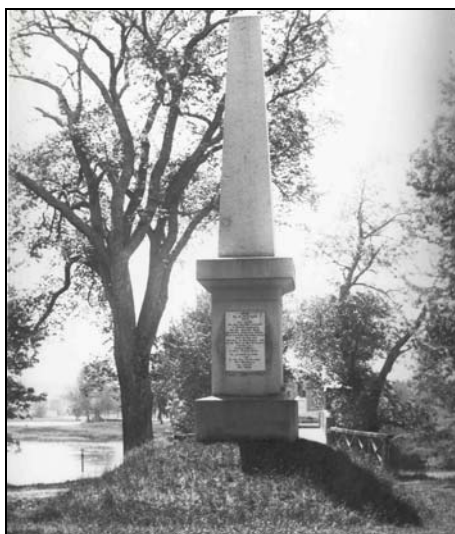
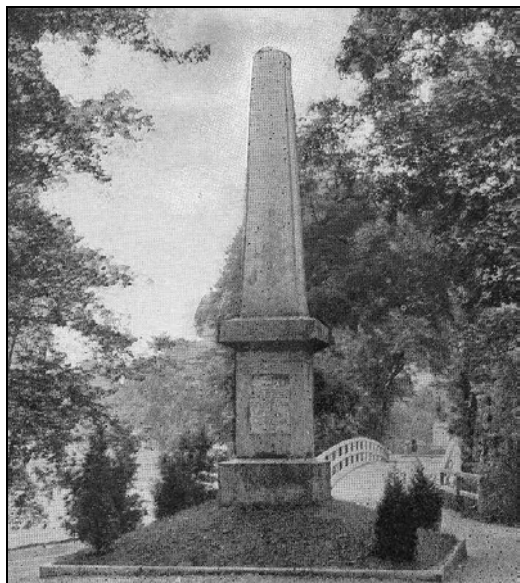
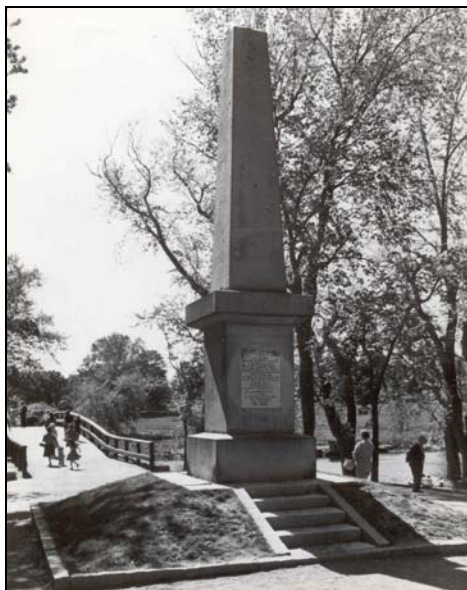
Historic Condition: The 1836 Battle Monument was erected on top of an earthen mound approximately 3 feet tall. It was originally surrounded by four iron fence panels. In c. 1875 the town removed the four panels and repositioned them around quarter-acre landform under The Minute Man statue, and placed four small granite “corner buffers” around the base of the rounded mound. Historic photographs from the 1800s and early 1900s depict a grass-covered mound under the statue. In 1909, during the same year the concrete 1909 commemorative North Bridge was constructed, the town squared the base of the monument and installed concrete curbing around its perimeter. Four small cedar trees were planted on the mound in 1915, one in each corner. Photographs taken c. 1920s do not depict the cedars, indicating they were removed soon after planting. In 1958, the town replaced the concrete curbing with granite curbing and installed rectangular granite slabs around the base of the monument to create a “narrow path.”<sup>301</sup> At the same time, the town constructed a “simple set of steps” leading up the eastern side of the mound (Figure 144).

**Figure 144. Historic images of the base of the 1836 Battle Monument**

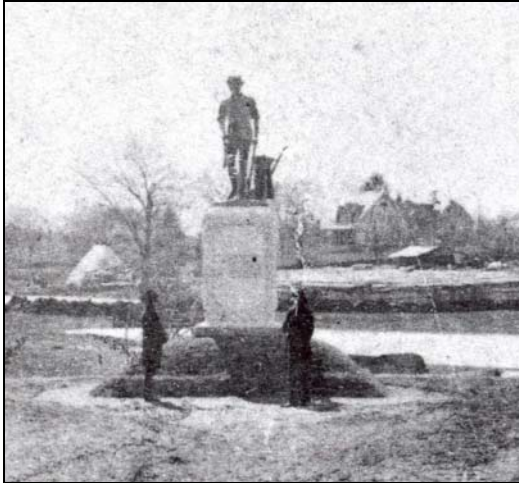
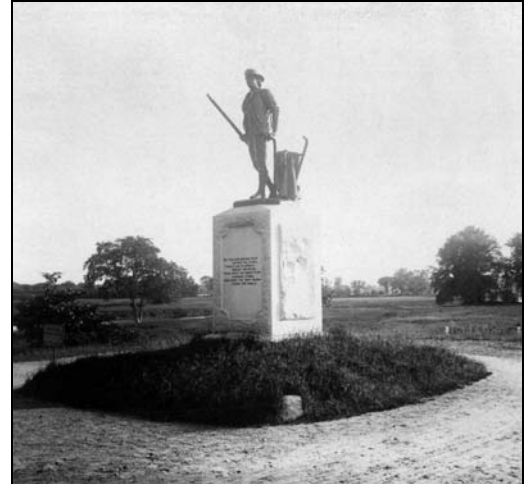
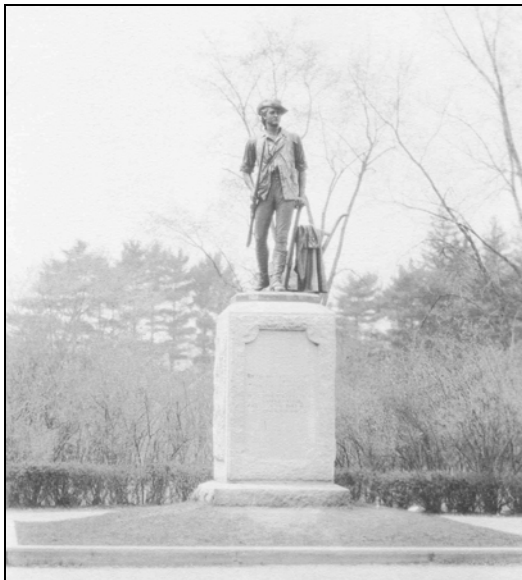
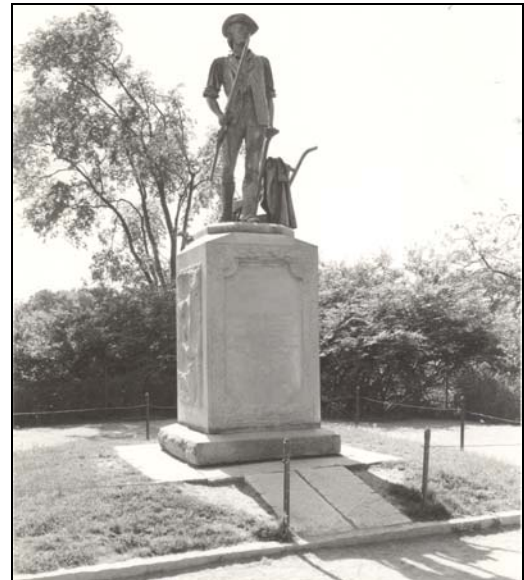
Historic Condition: The Minute Man statue was erected in 1875 on top of an earthen mound, approximately 3 feet tall. The town placed four small granite “corner buffers” around the base of the rounded mound. Historic photographs from the late 1800s and early 1900s depict a grass-covered mound under the statue. In 1909, during the same year the concrete 1909 commemorative North Bridge was constructed, the town squared the base of the statue and installed concrete curbing around the perimeter. In 1958, the town replaced the concrete curbing with granite curbing, and installed granite slabs around the base of the monument to “create a narrow path.”<sup>302</sup> A couple of granite slabs were also placed on the east and the west sides of the mound, between the granite curbing and the base of the statue. In 1958, the mound stood only 12 inches high and foot traffic had removed grass from its surface (Figure 145).<sup>303</sup>

The base of The Minute Man statue is a historic feature of the commemorative landscape. A comparison of existing conditions and historic photographs indicates the height of the mound under the monument has significantly decreased, partially because of erosion, and possibly from periodic applications of gravel on the roadbed surrounding the monument.

**Figure 145. Historic images of the base of The Minute Man statue**

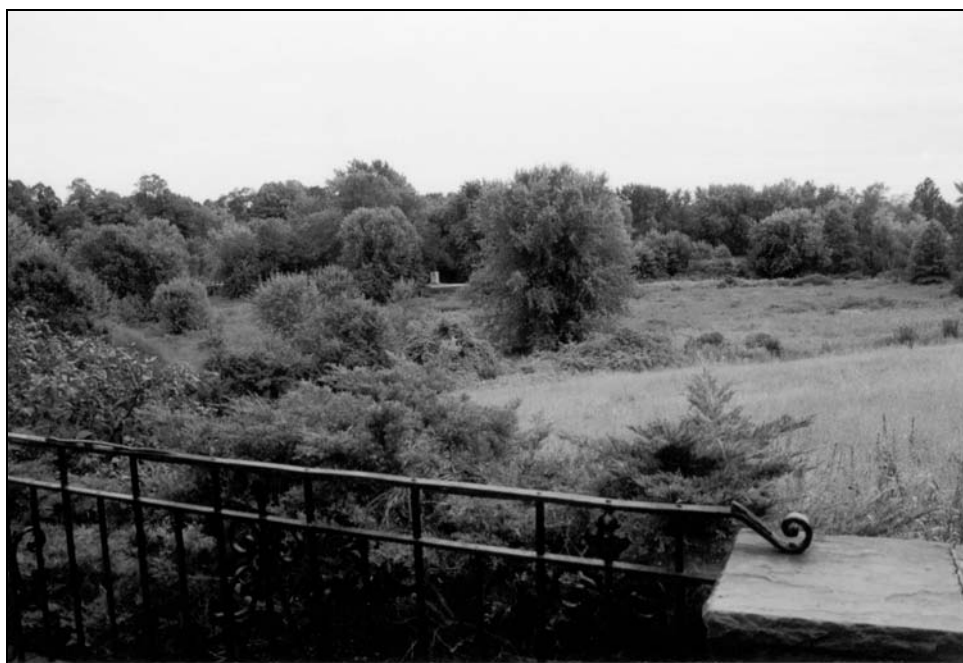
Figure 149. View southeast from the Buttrick lower garden overlook towards the commemorative landscape, 2002. Vegetation growing in the wetland along the river blocks views of the 1956 commemorative North Bridge. (OCLP)

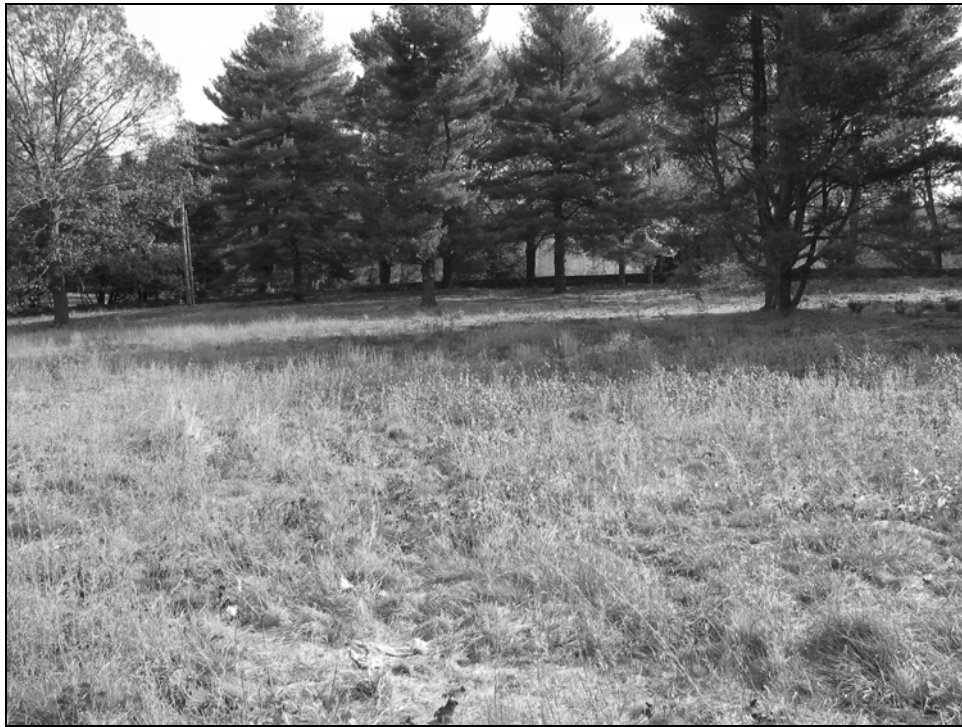
Existing Condition: Views across the battleground significant to the battle at the North Bridge are blocked by mature tree growth. Although several fields are actively farmed and a few more are routinely mowed, tree growth within the estate landscapes and within the un-maintained agricultural fields visually blocks historic views. Specific battleground views affected by mature tree growth include

**Figure 150.** View southeast from the Muster Field towards the 1956 commemorative North Bridge, 2002. Views of the battleground are blocked by mature evergreens growing. (OCLP)

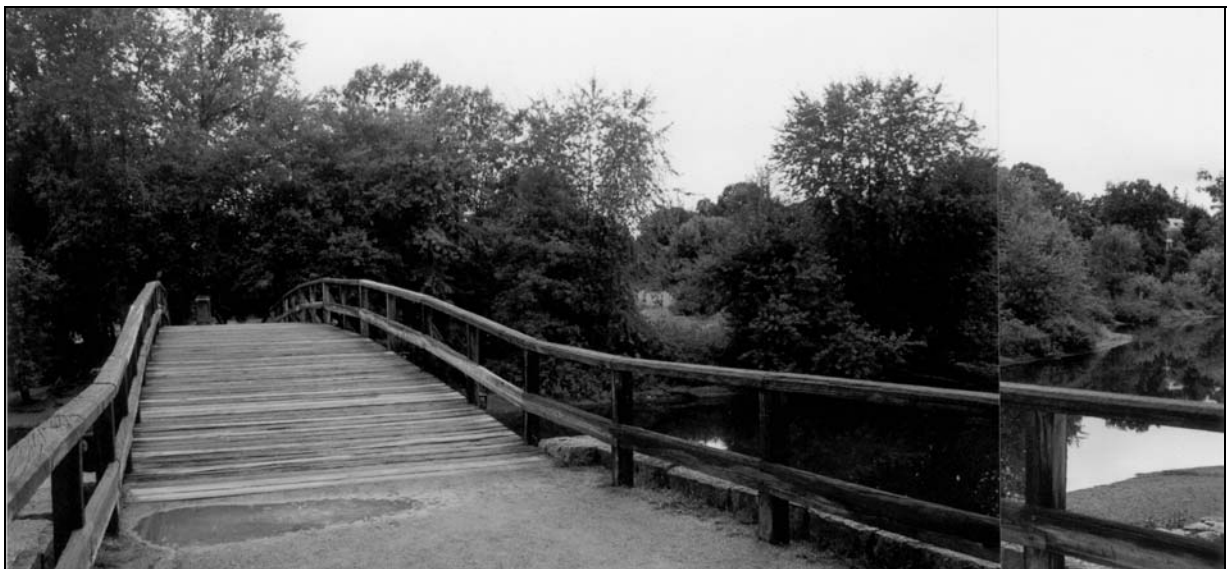
the view between the North Bridge and the Muster Field (Figure 150)  
the view between the North Bridge and the location of the east branch of the Groton Road  
the view between the North Bridge and the location of the west branch of the Groton Road (Figure 151), and  
the views between the Groton Road causeway and the British flank positions in the fields on the eastern side of the river, adjacent to Groton Road.

**Figure 151.** View west from the 1956 commemorative North Bridge towards the Muster Field and the west branch of the Groton Road, 2002. View blocked by trees and shrubs growing in the wetland along the Concord River. (OCLP)

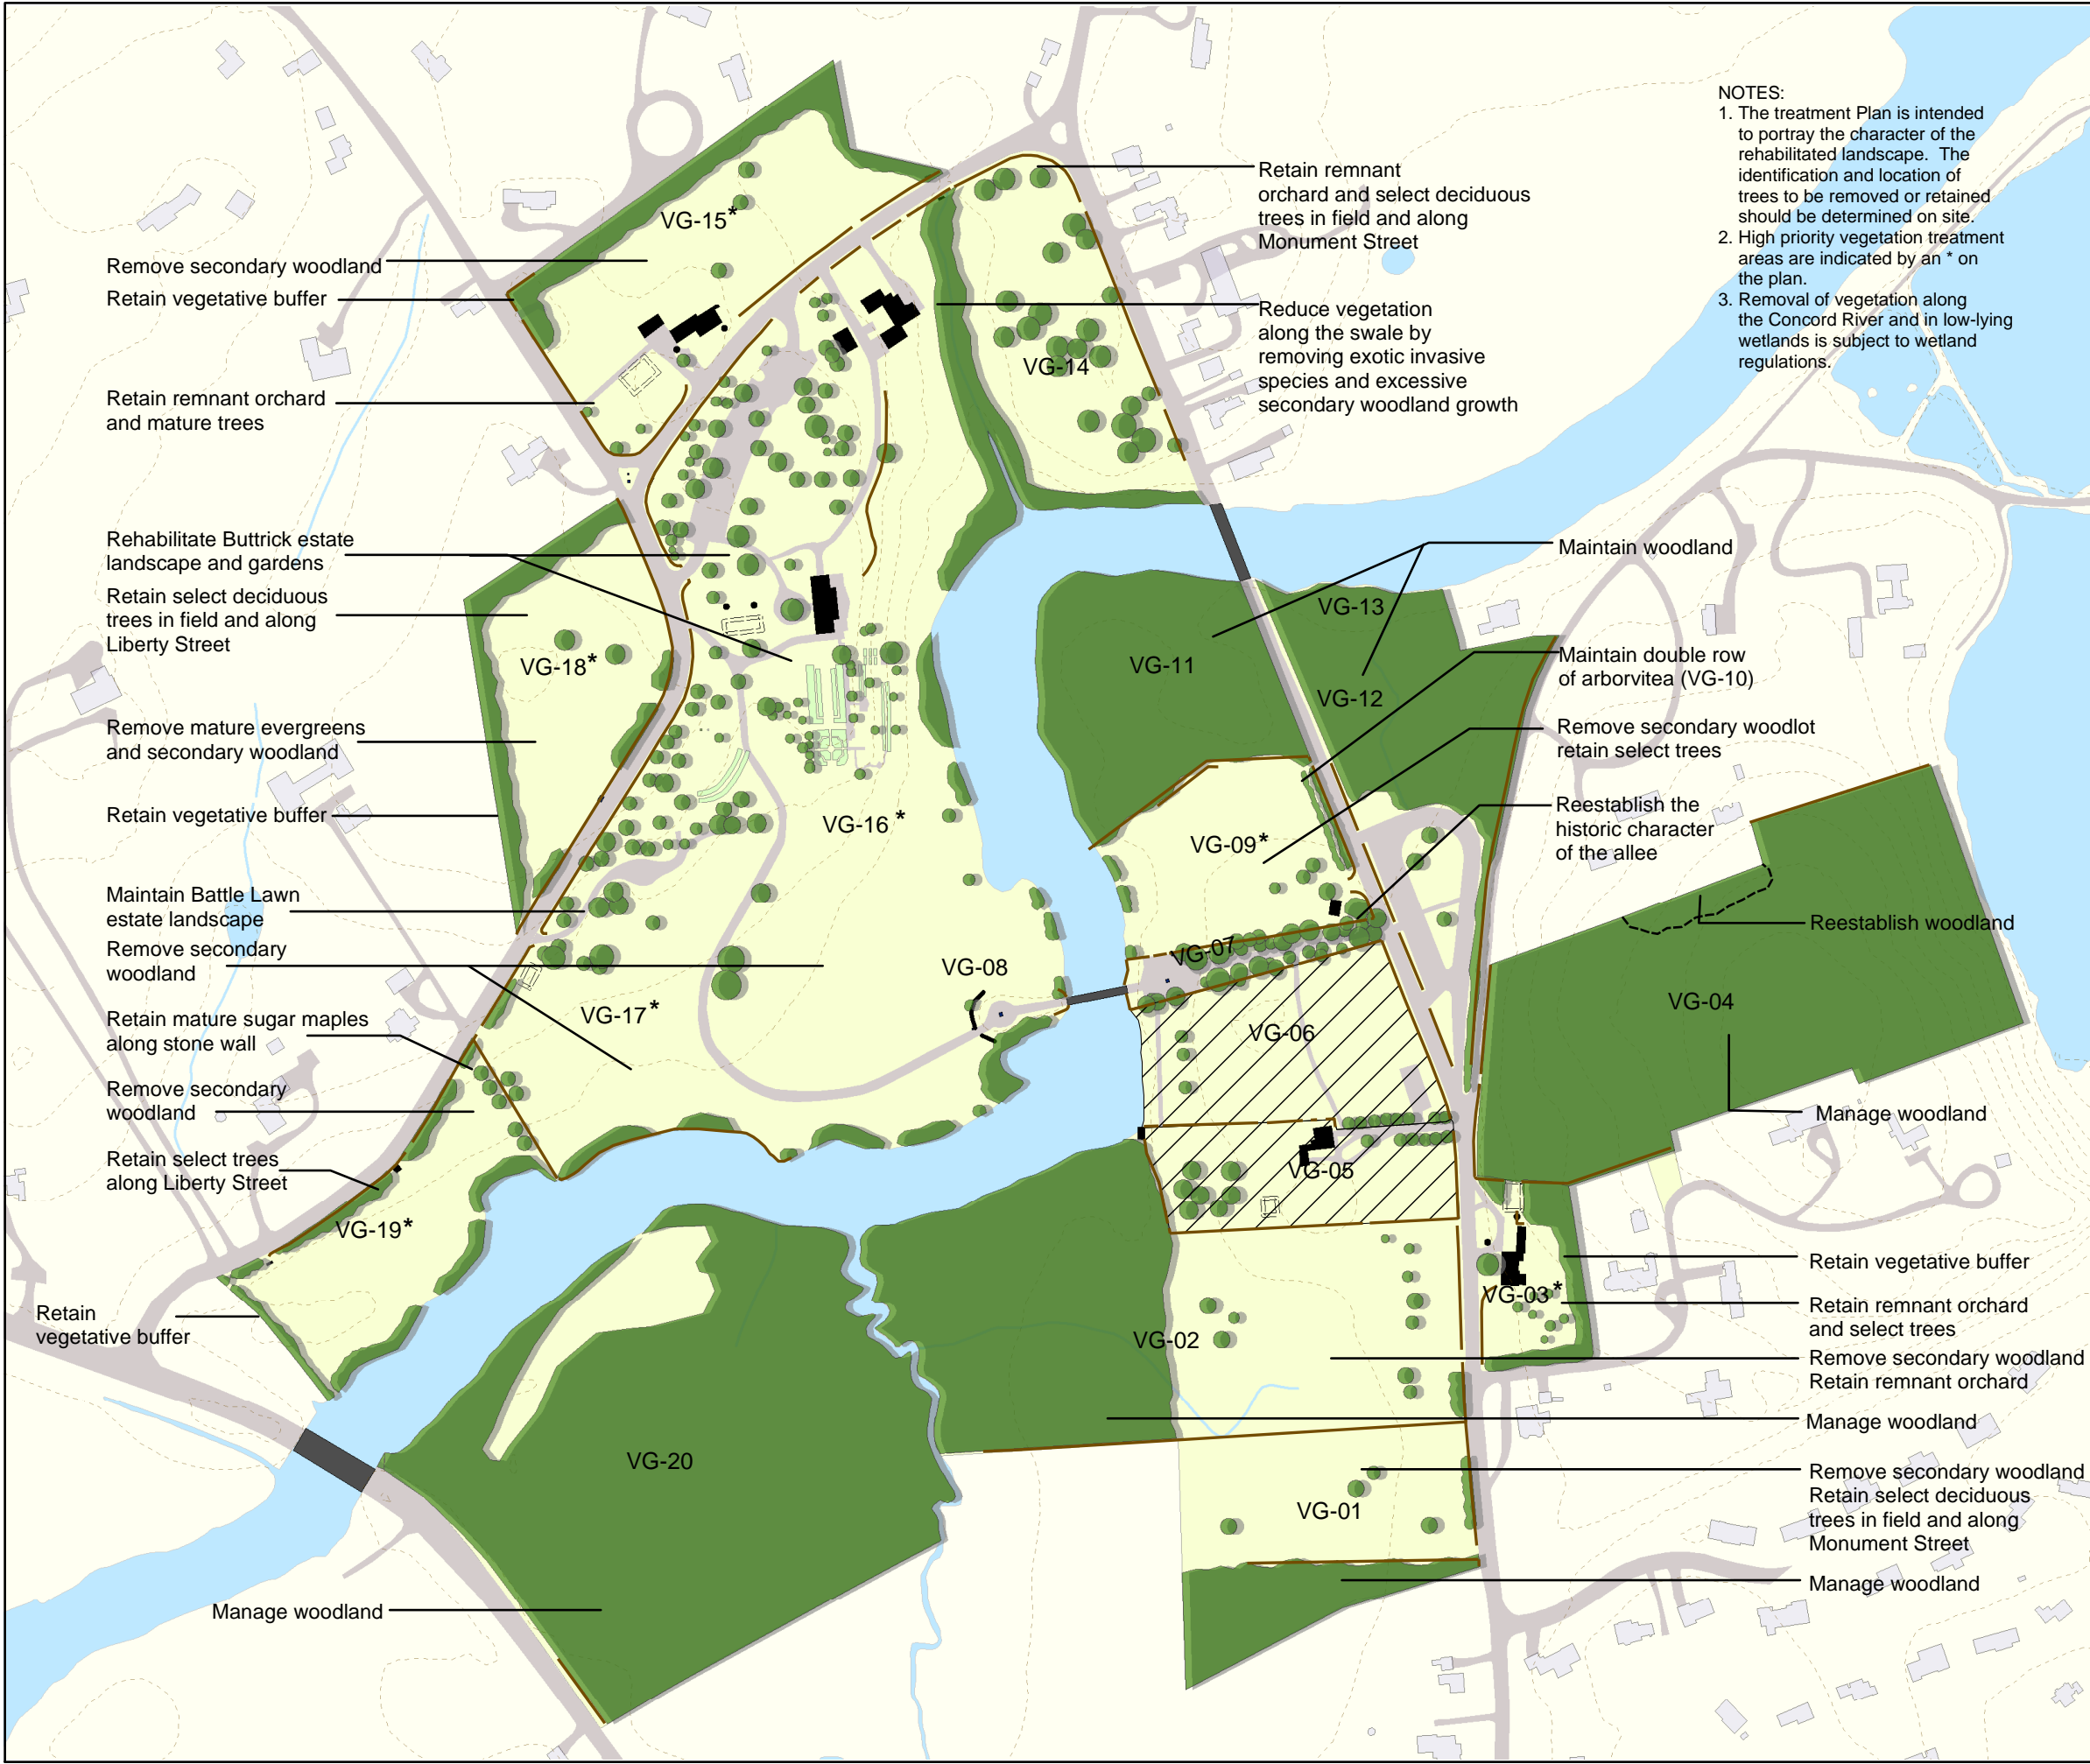
- NOTES:
1. The treatment Plan is intended to portray the character of the rehabilitated landscape. The identification and location of trees to be removed or retained should be determined on site.
  2. High priority vegetation treatment areas are indicated by an \* on the plan.
  3. Removal of vegetation along the Concord River and in low-lying wetlands is subject to wetland regulations.
